## SONARtrac® Technical Bulletin

Subject: 4-20 mA Output Change

TB001
Priority: 4
Date: 27-Feb-04
Rev: 01

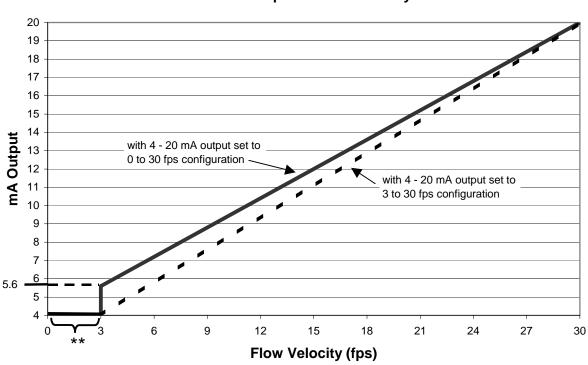
4 - 20 mA Output vs Flow Velocity

Software Version 01.05.10 and above changes scaling of the 4 - 20 mA output from 3 - 30 ft per sec to 0 - 30 ft per sec.

At the system Low Flow Cut Off of 3.0 fps, the value from the 4 - 20 mA output will be 5.6 mA.

<sup>\*\*</sup>At flows less than 3.0 fps, greater than 30.0 fps, or if the meter is not working, the display will read as configured in the setup of the output (i.e. 'Hold' (at last value), <4 mA, 4 mA or >20 mA).
