Cyclone Monitoring System Improves Operations at KUC's Copperton Concentrator

New technology allows mill to identify coarse material fouling flotation feed

By Dylan Cirulis and Jerin Russell

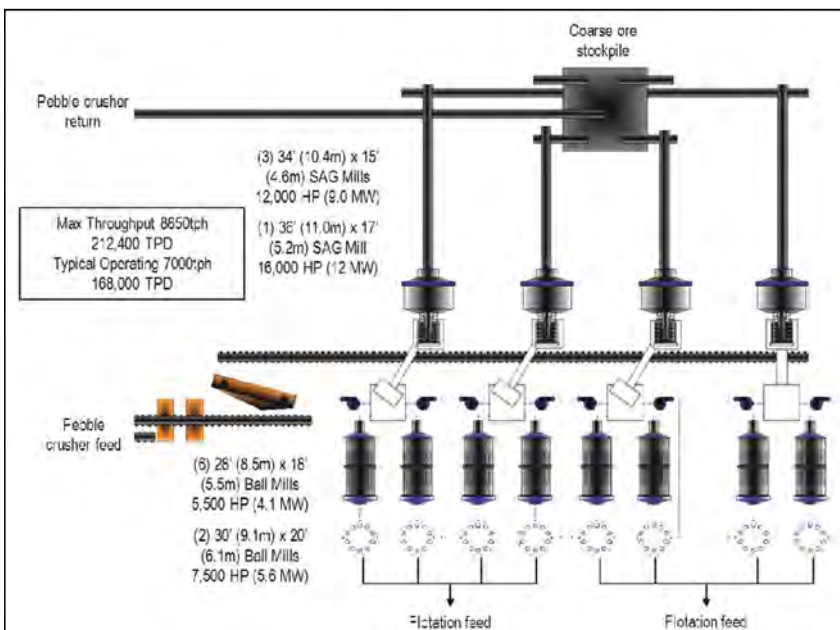
Figure 1—Rio Tinto Copperton Concentrator grind flow sheet.

Kennecott Utah Copper's (KUC) Copperton Concentrator has four grinding lines each consisting of one semi-autogenous SAG mill feeding two ball mills in a closed circuit with a hydrocyclone battery (See Figure 1). The aim of the ball mill/cyclone circuit is to produce the optimum flotation feed particle size while maintaining grind throughput. The optimal operating point is a trade-off between throughput, recovery and grinding cost.

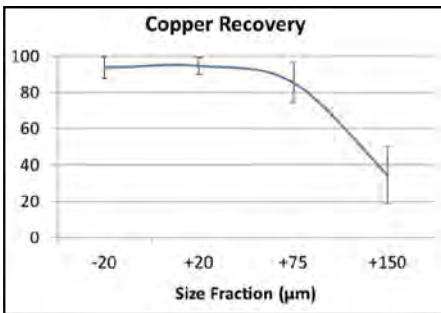
Figure 3—Copper recovery by size fraction.

Recovery of liberated and middling +150-micron mineral particles in the flotation circuit is significantly lower than -150-micron particles. Based on mineral liberation analyzer (MLA) data, the long term average +150-micron copper recovery is significantly lower compared with recovery of -150-micron particles (See Figure 3). It is also worth noting that the recovery of +150-micron size fraction is considerably more variable than for the -150-micron size fraction.

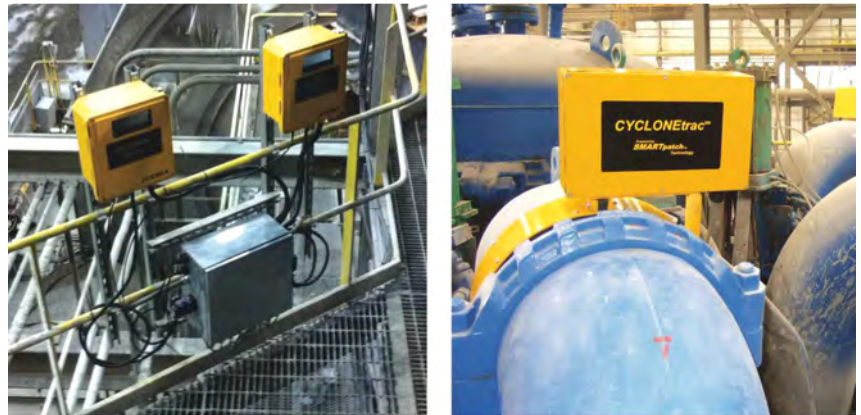
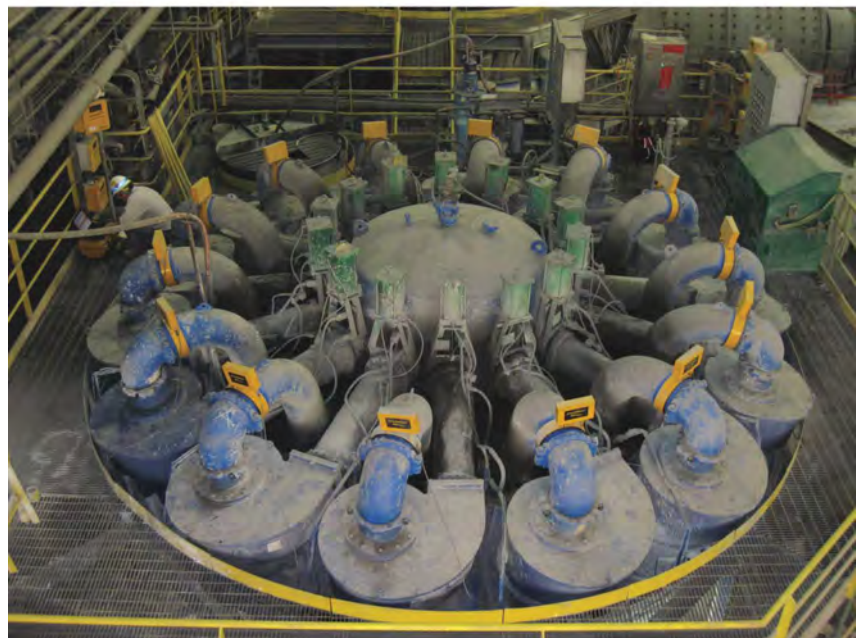
Figure 4—CYCLONetrac installed on hydrocyclone battery 8.

A full system was then built and installed on all eight cyclone batteries in the grind plant. Figure 4 shows the transmitters and junction box for one battery, the CYCLONetrac band installed on an overflow pipe, and a full battery instrumented with bands.

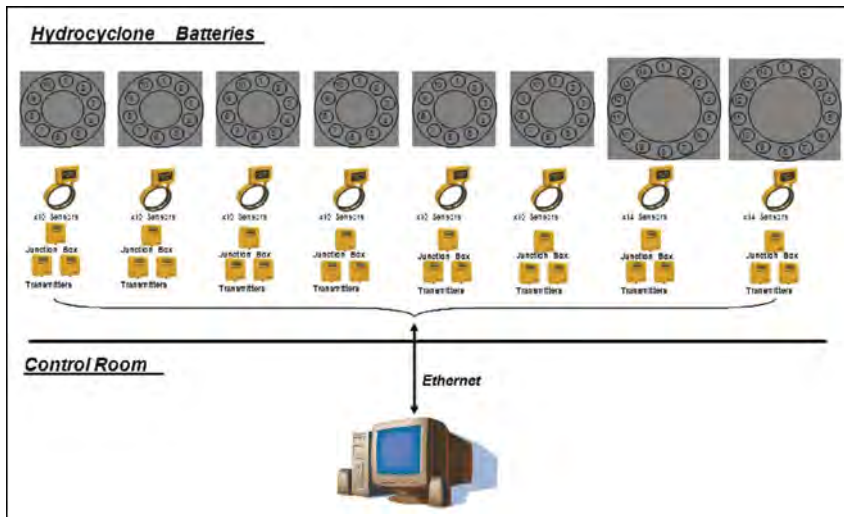
Figure 5—CYCLONetrac system diagram.

The system consists of a sensor and preamplifier attached to the external pipe surface on the overflow of each cyclone. A schematic of the system is shown in Figure 5. The preamplifier outputs are connected to transmitters which perform

the first level data processing for each battery. The data accumulated by the transmitters is aggregated by a computer in the Copperton control room. This data is used by the CYCLONetrac system to determine the operational state of each individual cyclone and of each battery of cyclones. In addition to the real-time display, data is stored for local review and transmitted to the CiDRA data center for the generation of daily and weekly performance and utilization reports. Both the displayed data and the summary reports facilitate smart maintenance scheduling and aid in troubleshooting to reduce the downtime associated with periodic maintenance and repairs.

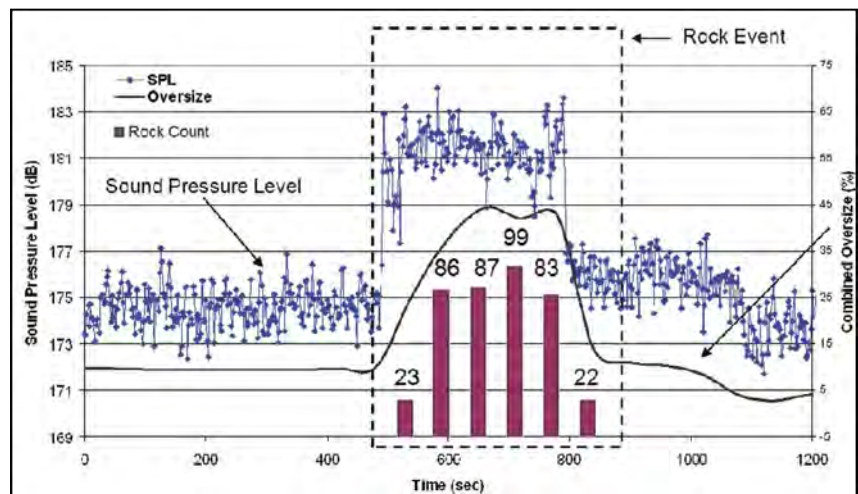
Figure 6—Rock event data, 2/3/2009.

Using the defined system threshold parameters the system successfully detects a sustained rock event. This data was then compared to Copperton's oversized particle detection system data from the data historian. The CYCLONetrac system detected this event as displayed in Figure 6. The blue trace is the sound pressure level (SPL) calculated by CYCLONetrac. The blue trace shows that the SPL of the acoustic signal for hydrocyclone No. 3 increases more than 6 dB during the

event. The overlaid maroon bars represent the number of impacts detected by CYCLONetrac for each minute of the event (from rocks striking the inner pipe wall), as defined by the algorithm.

The event terminated rapidly (at 800 seconds on the plot) when feed

flow stopped to the effected cyclone by closing the isolation valve. The SPL dropped very quickly while the number of rocks and the oversize detector signal roll off more slowly due to slower sample rates.

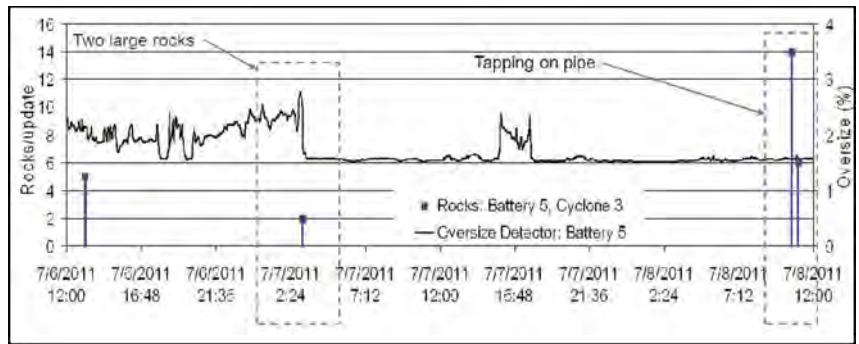
Figure 8—Sample basket test data.

The number of rocks large enough to be detected was small, so it is only an assumption that the rocks collected were those causing the impacts. The highlighted region on the left side of Figure 8 shows the corresponding rise

in the output of Copperton's oversize particle detector, at about 2:24 on July 7, 2011, and the two wall impacts that were detected by CYCLONEtrac at the same time (assumed to be the two large rocks that were recovered from the sample basket).

A short sampling campaign completed in July 2011 was designed to further confirm the performance of the system. A sample basket assembly was attached to the overflow discharge of two cyclones on separate batteries for 24 hours and 48 hours, respectively. During these two sampling periods, the CYCLONetrac system determined the number impacts on the pipe wall, indicating that rocks were reporting to the overflow of the particular cyclone under test. At the conclusion of the sampling period, the material collected in the basket was removed, dried and analyzed. There was a correlation between the number of rocks (wall impacts) detected and the number of rocks collected. Of interest is that at the point where the rocks were detected, the combined overflow % oversize detector signal also spiked.

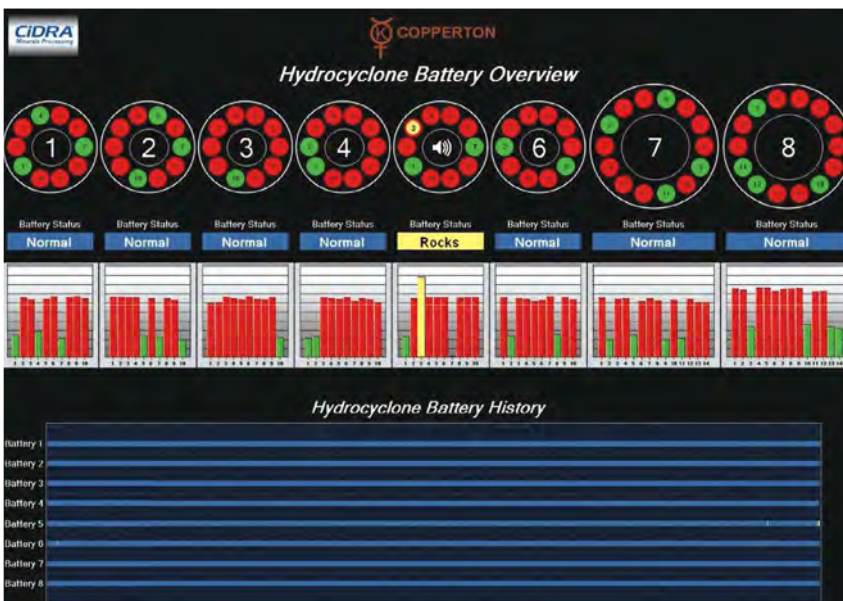
Figure 7—Screen capture of control room computer monitor.

This event was isolated to a single cyclone, as shown on a screen shot of the control room interface in Figure 7, and the excursion in SPL and rock count is not detected on any of the other cyclones. The solid black line plotted with SPL is from Copperton's oversized particle monitor (in percentage of sample) from the combined overflow of all 10 cyclones in the battery. Thus an event that would have been generally associated with the whole battery has been isolated by CYCLONetrac to the single cyclone affected.
